1. PURPOSE AND SCOPE OF THIS MEMORANDUM

This memorandum summarizes a site survey performed on July 18, 2008 to evaluate the condition of ADA-mandated accessibility at the Council on Aging in Pembroke Massachusetts. After a description of the site and interior conditions of the building, recommended improvements are provided in Section 7, beginning on page 8.

The subject property is the Pembroke Council on Aging at 148 Center Street.

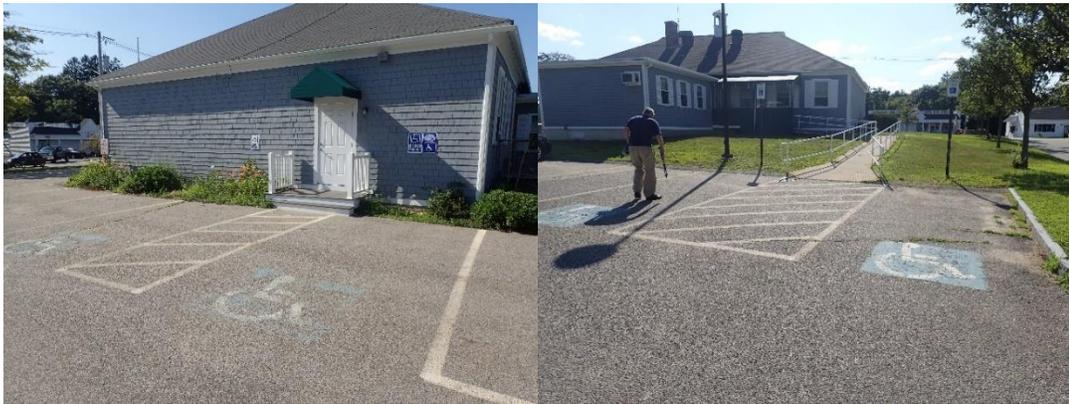
The Council on Aging is marked by a yard sign along Center Street and another above the main entrance, both clearly visible from the public way. The parking area is paved and contains approximately 13 marked parking spaces. Two of the marked spaces are designated as accessible. These spaces, however, are located next to a secondary, non-accessible entrance door at the south side of the building. The spaces have the correct signage, but there is no designated van-accessible space.

The condition of accessible parking spaces and accessible routes is generally good, with some minor deterioration of asphalt pavements. The sloped pathway to the rear (East) Council on Aging entrance is generally compliant but has gaps or steps in excess of ½" due to differential settlement of pavement.

i. Re-stripe and designate a van-accessible space and access aisle.

ii. Relocate all accessible parking for optimum proximity to the West entrance ramp.

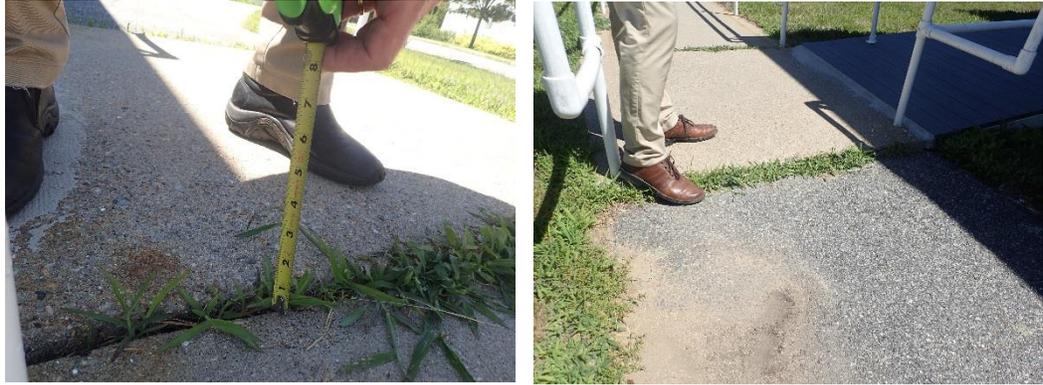
Both entrances are accessed by ramps. The West (Center Street) ramp has been recently installed and appears to be fully ADA-compliant. The East ramp at the Library side is older, and is ADA-compliant in its overall dimensions, however there is differential settlement between pavements at the intermediate landing, which has resulted in weed growth and excessive vertical and horizontal gaps of 1/2:" or more.

i. Correct gaps and steps at the intermediate landing of the East (Library) side ramp. This may involve grinding, feathering or replacement of asphalt or concrete paving.

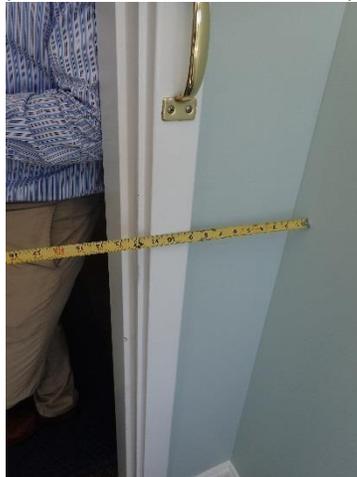
Both exterior doors have power operators. The interior vestibule at the West entrance is non ADA-compliant due to the limited distance between the inner and outer doors; 4'-8" is provided instead of the required 7'-0" (7'-6" may actually be required in this case due to the large (42" wide) interior door. However, this may not be a violation if the inner door is fixed in its open position whenever the facility is in operation.

There is also only 12" of space at the latch-pull side of the interior door, where 18" is required.

The main (West) entrance has a non-compliant interior vestibule, which lacks adequate space between the inner and outer doors and latch-pull clearance at the inner door. This is likely to pose a barrier to a person using a wheelchair unless the inner door is held open.

- a. West Entrance Vestibule  
Reconfigure the vestibule and/or inner door to provide the required door clearance dimensions in the vestibule. This will require additional design analysis, but may involve reducing width or changing the swing of the inner door. Building Code considerations may also apply, based on the occupancy classification and number of occupants in the building.

- d. Door Clearances and Swings  
Reconfigure or relocate door openings and/or change door swings to allow 18" clear at the latch-pull side of doors, plus 12" clear at the latch push side where the door is equipped with a closer. This will primarily affect the West entrance vestibule, as discussed above.

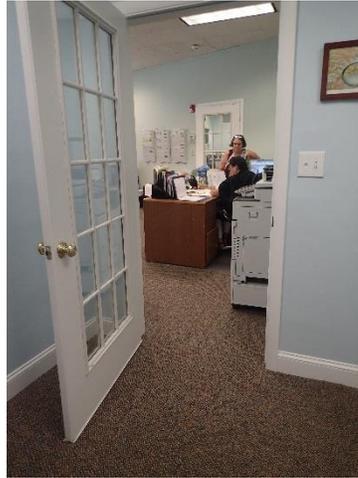
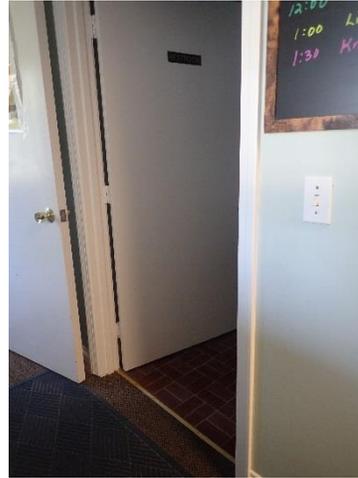
The interior signage at the Council on Aging is limited and does not meet ADA standards. Few of the permanent rooms and spaces are clearly identified. Signs

are mounted on doors instead of on the wall adjacent to the latch, and there are no Braille characters.

- b. Interior Signage  
Provide consistent ADA-standard signage for all accessible doorways, routes and spaces.
- c. Door Hardware – priority items  
Provide lever-handle hardware at any doors expected to be used by the general public. Ensure single-action release (from the room or exit side) of doors subject to locking (i.e., no separate deadbolts, etc.)
- d. Service Counters – interim accommodation  
Where ADA-accessible height (36" or less) counters are not available, ensure that alternate accommodation is available. This can include a desk or table of appropriate height in the same service area, equally accessible to all users.
- e. Door Clearances – furniture interference  
Remove or relocate furniture to allow 18" clear at the latch-pull side of doors, plus 12" clear at the latch *push* side where the door is equipped with a closer.

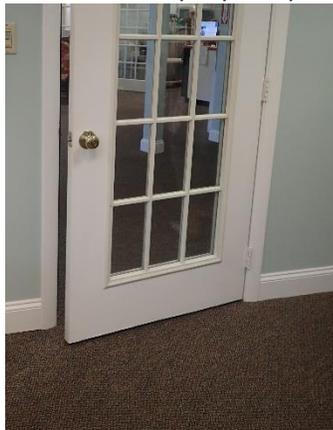
- Lack of appropriate hardware. Most doors have standard doorknobs, which cannot be operated with a closed fist or without grasping. Lever handles or simple push-pull hardware are required.

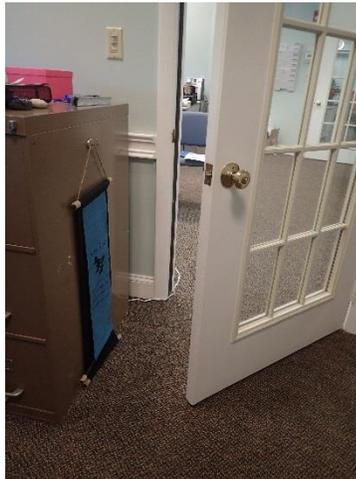
- Lack of adequate side clearance at doors. A minimum 18" clearance is required at the latch-pull side of any passage or entry door. This was

specifically noted at the interior door at the West entrance and at one or more interior locations.

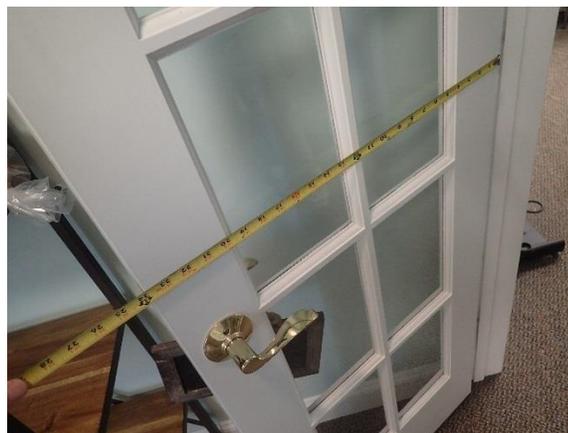
- Size of door leaf. At one or more locations it was noted that the width of individual door leaves at double (French) doors was 24", where ADA requires a minimum clear width of 32" for accessible doorways (this is typically achieved with a nominally 36" wide door leaf).

- b. Door Leaves – double door locations  
Replace double 24" wide door leaves with a single 36" wide door plus a 12" fixed sidelight (or inactive leaf, which can be secured with operable top and bottom bolts).

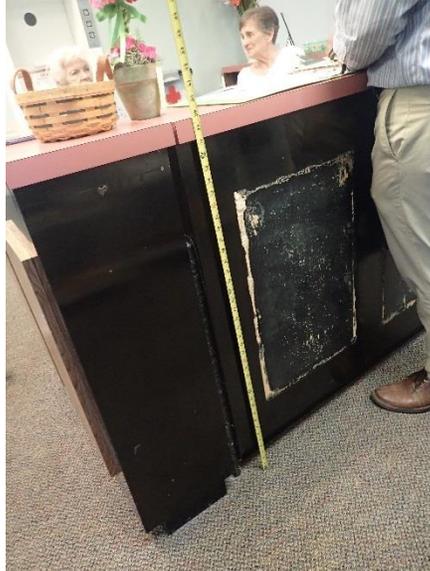
The main reception desk counter is 39" high, which exceeds the ADA maximum of 36".

- c. Service Counter – transaction height  
Provide a permanent section of the Reception counter at ADA-compliant height (36" or less). This section should have the same approach path and access to customer services as higher-level sections.

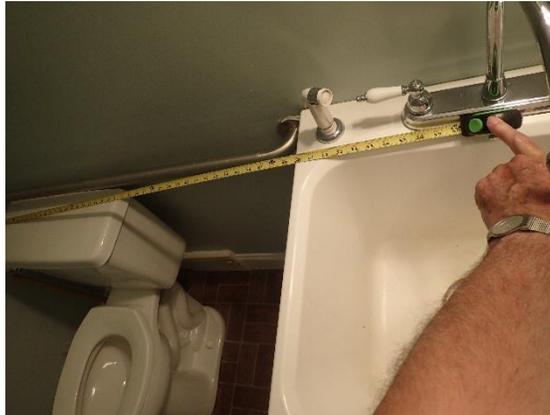
- A large utility sink has been installed between the toilet and the lavatory, reducing the available clearance at the back wall to 50". The ADA required minimum is 60".

Remove utility sink to allow 60" rear-wall clearance at toilet.  
Relocate lavatory and/or modify door swing to provide required access clearance at door.

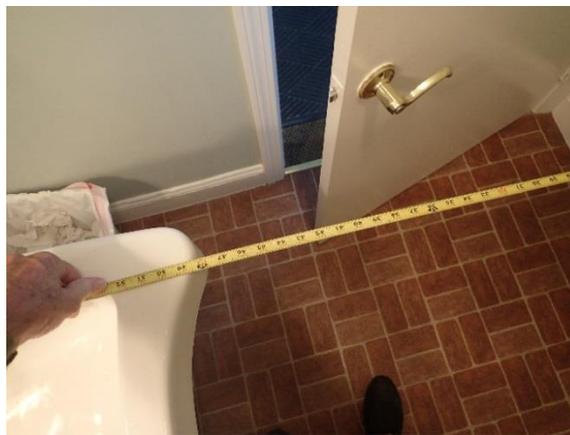
- There is insufficient clearance between the door and the lavatory; this may be addressed by modifying the door swing or relocating the lavatory. A smaller lavatory may also be considered.
